Dartmouth Fire District No. 1

10 Bridge Street
Dartmouth, MA. 02748

Station Assessment

WSA Project #18-050

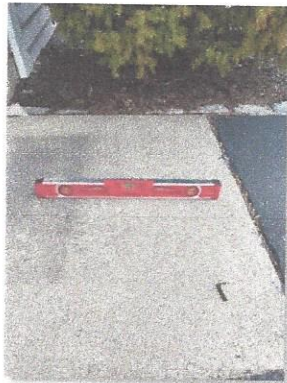
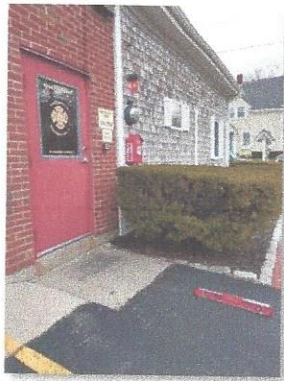
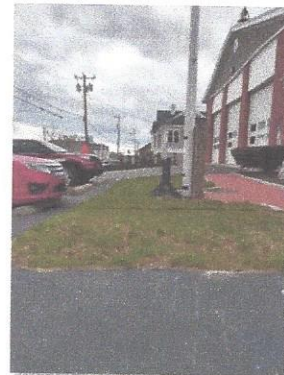
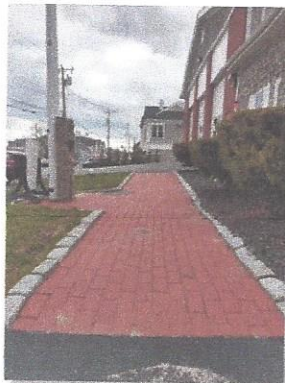
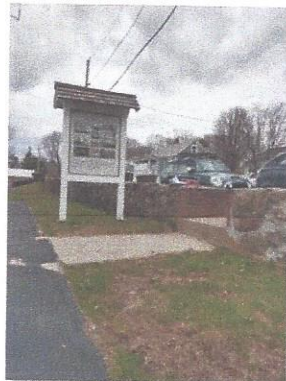
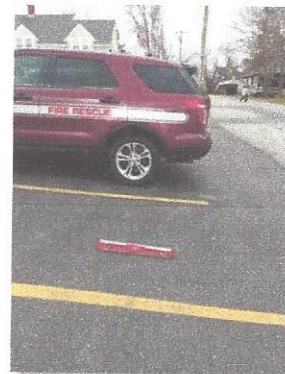
1. Observed Condition: The main entrance to the building on Bridge Street is non-compliant. The landing outside of the main door exceeds allowable slope and is in excess of 11%. In addition to slope, the landing does not meet the minimum size requirement of 60" x 60". A step of 7 ½" at the door leads into the station. There is no accessible parking on this side of the building. The

access to this door from Cleveland Street includes a stair with a 9" rise and a brick paver walk. (Photos 1-6).

Proposed Solution - The main entrance can be made accessible by modifying the first parking space near the driveway to create a van accessible space. This would require lowering the front of the space significantly to stay within the maximum 2% allowable slope. A switchback ramp would be constructed from the front of the new access aisle toward Cleveland Street and following the existing asphalt walk to the brick paver walkway toward the entrance door. This new ramp would be built up to the level of the threshold of the entrance door. Handrails will be required at this ramp.

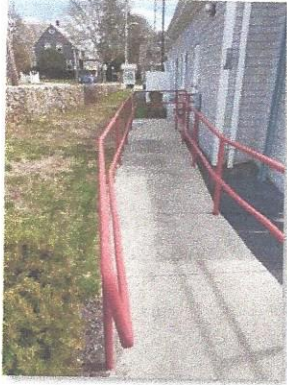
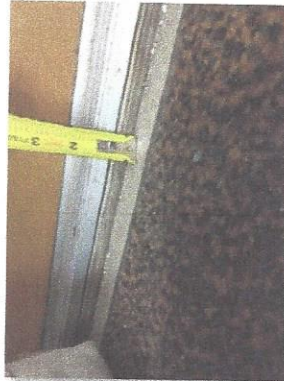
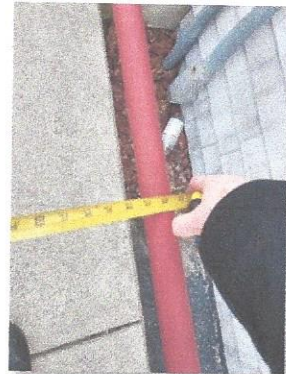
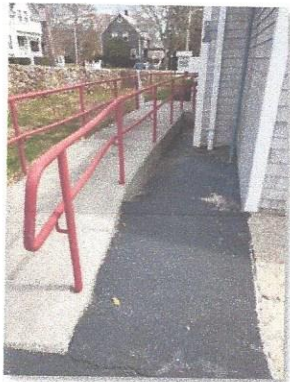
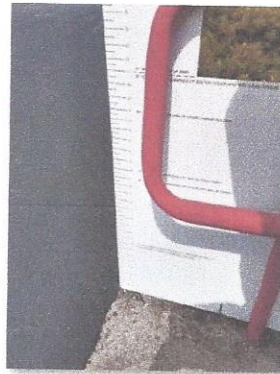
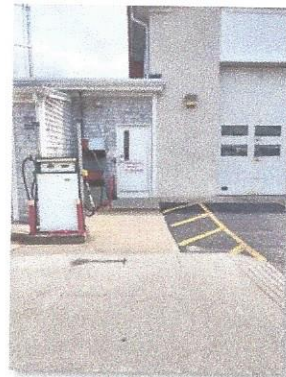
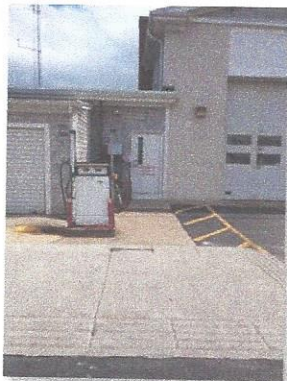
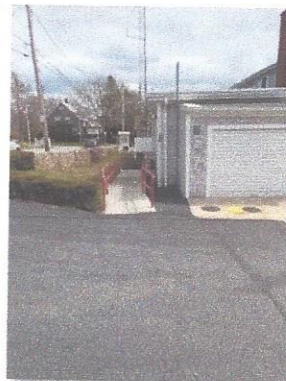
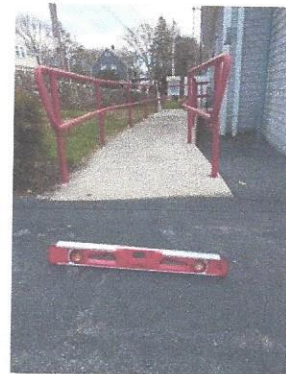
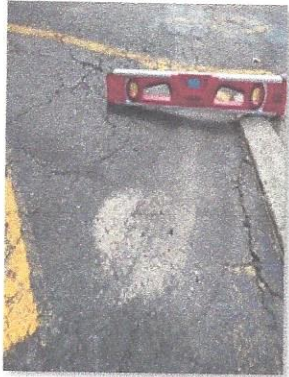
2. The entrance at the side/rear on the Cleveland Street side of the building is currently used as the accessible entrance. A ramp leads from the parking lot to a door with a non-compliant threshold. The ramp does not meet requirements for cross slope, distance between handrails, edge protection and handrail extensions. One accessible parking space exists on this side of the building; at 8' wide with a 4' wide access aisle it is not compliant for size and must be van accessible. It is also partially located directly in front of one of the Apparatus support bays overhead doors. The route from this space to the bottom of the ramp has non-compliant changes in level and a cross slope exceeding 11% at its worst point. The path of travel is in disrepair (Photos 7-16).

Proposed Solution - The entrance at the side/rear of Cleveland Street would require reconstruction of the route from a (new) van accessible parking space to the existing ramp. This ramp will require reconstruction to meet code for width, cross slope and handrails. The door would require a new threshold.

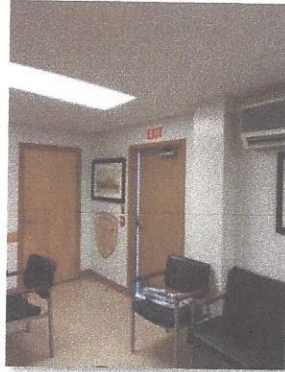
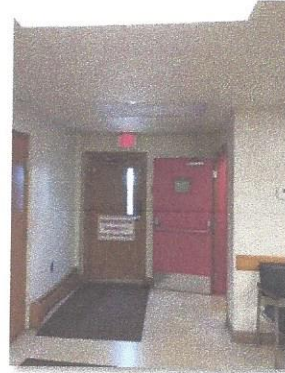
3. All exits with a lighted exit sign also require a tactile sign. (Photos 17-18)

Proposed Solution - Provide Tactile signage to all exits.

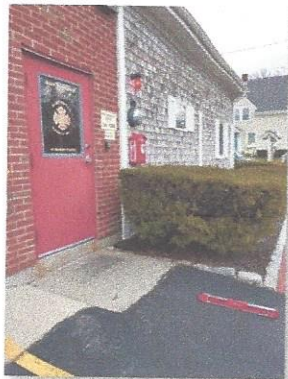
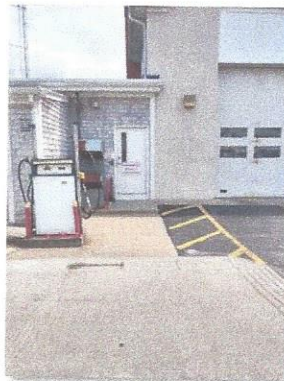
4. Non-compliant entrances must have signage to direct users to the accessible entrance. (Photos 19-20)

Proposed Solution - Non-compliant entrances should receive signage identifying the location of the accessible entrance.

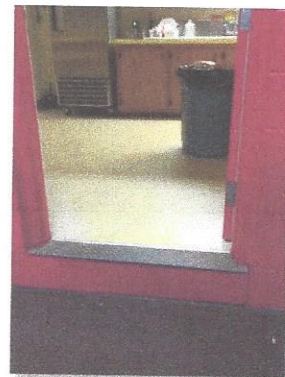
DARTMOUTH FIRE – 21

5. The existing vehicle bays are used as public assembly areas for meeting and elections. The entrance to the bays (as noted above) is non-compliant for slope and cross slope. Once inside the bays there is no access to the restrooms, the chief's office or the kitchen which is sometimes used by the public. Entrance from the rear of the building does not gain access to this floor level without a 7 1/2" step. (Photo 21)

Proposed Solution - Correction of the main entrance noted in Item 1 and a ramped area leading to the level accessed by the 7 1/2" step.

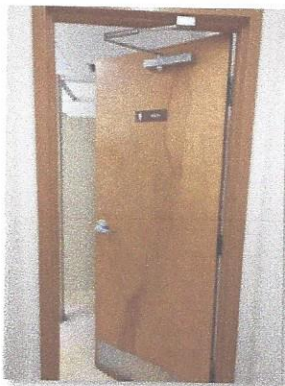
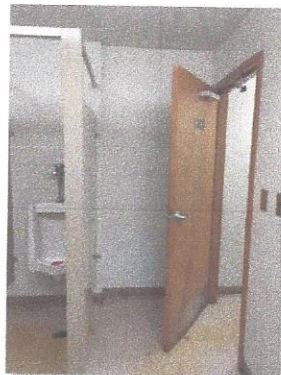
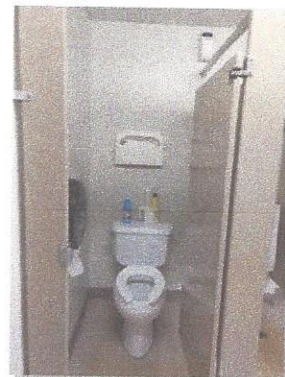
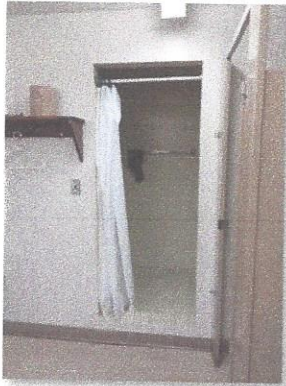
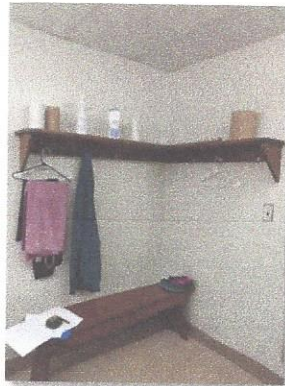
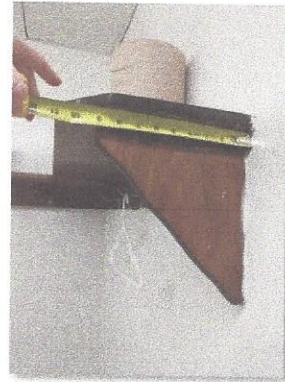
7. Men's Restroom: (Photos 22-27)

- a. The sign is non-compliant.
- b. There isn't sufficient space outside of the room to allow for push space for the door. The hallway would be required to be 48" wide for any push door to be compliant.
- c. The door does not meet the minimum opening dimension of 32" clear.
- d. There isn't sufficient pull space for the door on the inside of the room. The urinal screen narrows the space to 41", 48" is required.
- e. The toilet stall, at 36" wide, does not meet the minimum requirement of 60" wide and does not contain either side or rear grab bars.
- f. The door to the stall has only a 21¾" clear opening.
- g. The toilet paper dispenser is not at the correct height or distance from the toilet.
- h. The walk-in showers have a 7 ½" step for access
- i. The towel bar is mounted too high
- j. There are protruding objects on the wall (shelves).

Proposed Solution - Total reconstruction required.

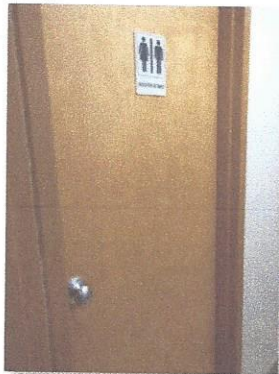
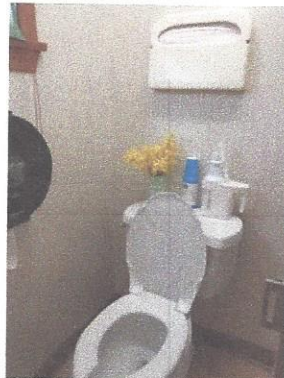
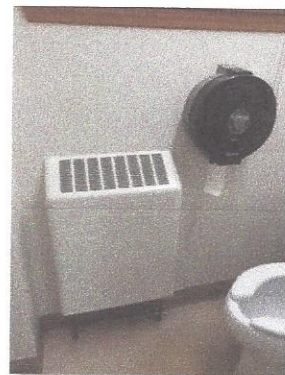
8. Unisex Restroom: (Photos 28-30)

- a. The sign is mounted at the wrong height.
- b. The accessible restroom sign is mounted on the door to a non-accessible restroom.
- c. The door has a door knob instead of a handle.
- d. There isn't sufficient space outside of the room to allow for push space for the door. The hallway would be required to be 48" wide for any push door to be compliant.
- e. The door does not meet the minimum opening dimension of 32" clear.
- f. The toilet stall, at 36" wide, does not meet the minimum requirement of 60" wide and does not contain either side or rear grab bars.
- g. The door to the stall has only a 21¾" clear opening.
- h. The toilet paper dispenser is not at the correct height or distance from the toilet.
- i. A space heater and permanent build-out infringe on the required clear floor space for the toilet.

Proposed Solution - Total reconstruction required.

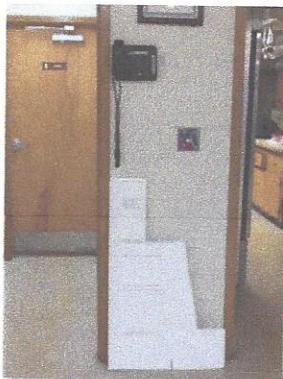
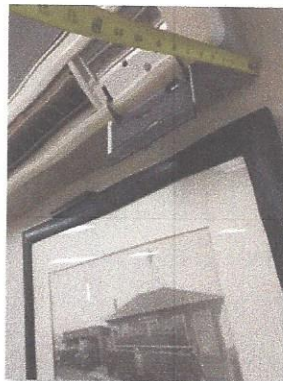
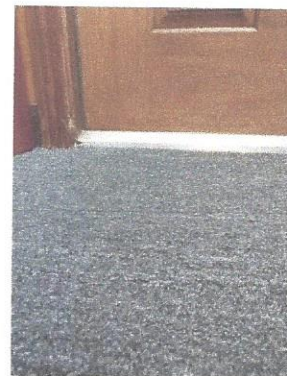
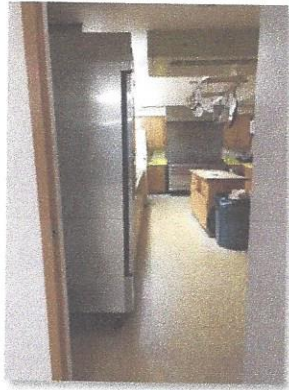
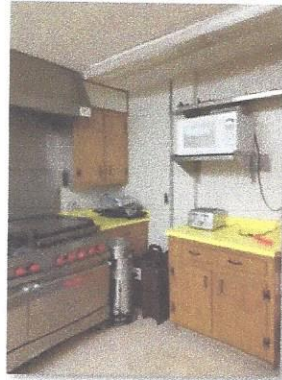
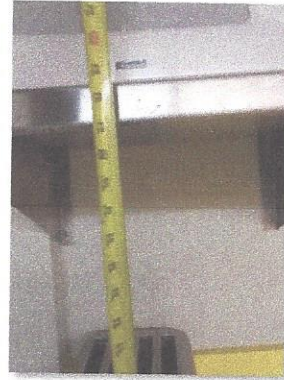
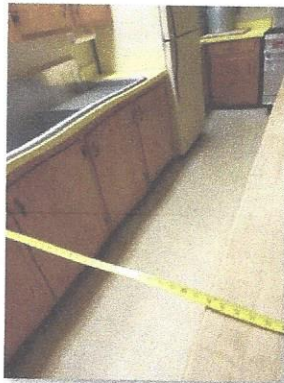
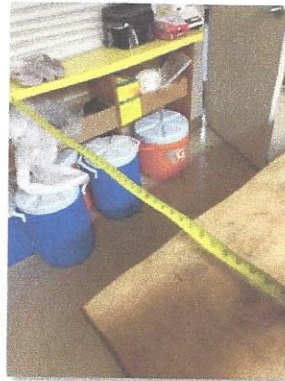
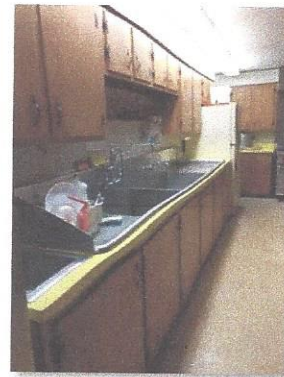
Access to other items: (Photos 31-39)

9. There is insufficient push space at the door at the front of the building

10. The telephone in the day room is mounted too high

11. There are protruding objects in the day room (air conditioners)

12. There are multiple doors with non-compliant thresholds

13. The refrigerator in the kitchen blocks required clear floor space for the door

14. Items in the kitchen exceed allowable reach ranges

15. The required space between island and counters does not exist

Proposed Solution – Reverse the swing of the door.

Proposed Solution - Remount the telephone to a height not to exceed 48".

Proposed Solution - Install guards below protruding objects to decrease protruding part to less than 4".

Proposed Solution – Install compliant thresholds on existing doors.

Proposed Solution – Relocate the existing refrigerator out of door clear floor space.

Proposed Solution - The kitchen will only need to be modified further if it is to be considered public space or if an employee who used the space requires it to become compliant.
