Dartmouth Fire District No. 1

10 Bridge Street
Dartmouth, MA. 02748

Station Assessment

WSA Project #18-050

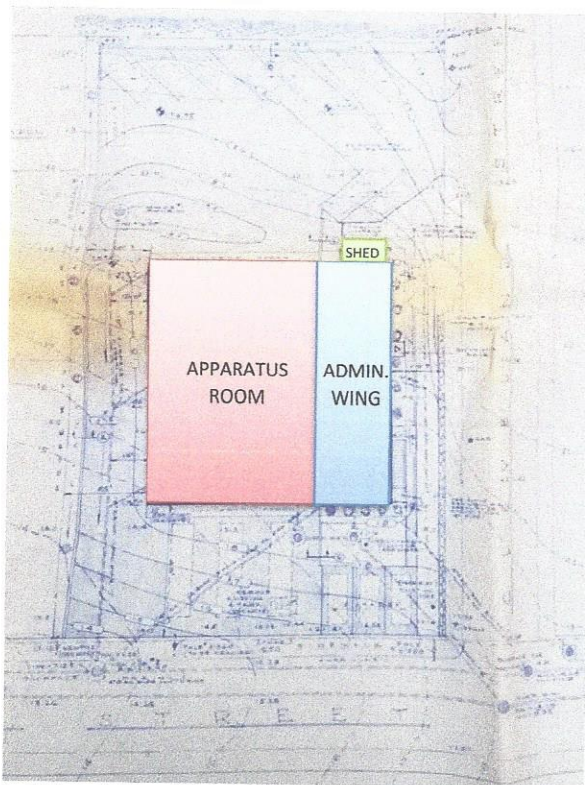
The Apparatus Room (shown in the image below as the red shaded area) consists of an open +/- 4,400 sq. ft. single level space that, as previously noted, is a pre-engineered metal building with masonry exterior walls. The adjacently attached Administrative Wing (shown below as the blue shaded area) consists of a main ground floor level and a full basement, both totaling approximately 4,000 sq. ft. This

area of the building currently houses the administrative, training and residential sleeping quarters of the station. Its main structure is composed of steel beams and columns on a concrete foundation with a wood framed floor, exterior wood stud walls and a low slope membrane wood framed roof. The rear attached shed (shown as the green shaded area) is of wood frame construction and is an unfinished space. Adjacent to the existing shed there is currently an existing fuel pump with two underground fuel storage tanks.

A visual examination of the existing building and its structural elements led to the determination that the main structure of the building as a whole appears to be in good condition with the exception of the existing Drill Room Floor in the "Drill Room". The floor showed signs of excessive bounce, suggesting that some delamination from the subfloor may have taken place which, coupled by the lack of blocking between floor joists, could be allowing for the bounce felt in the floor. From an insulation perspective, some of the existing roof fiberglass batt insulation (R-19) in the Administrative & Residential building seems to have fallen down from between the roof joists or is missing, and the existing 2x4 wood stud exterior walls contain 3 1/2" fiberglass

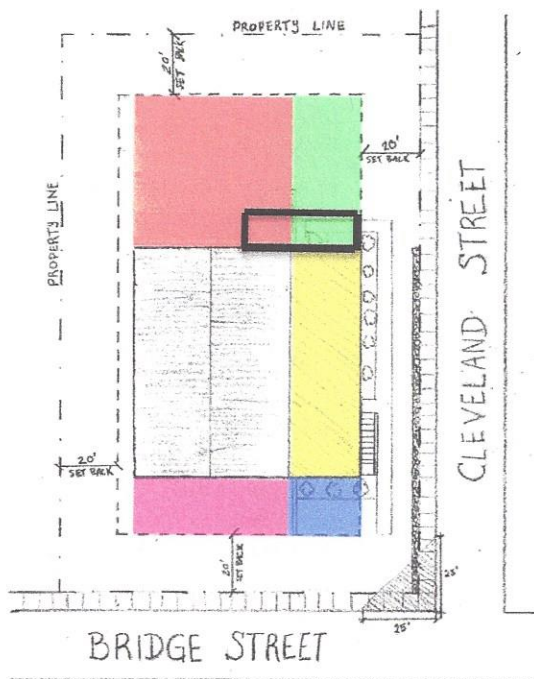
As previously noted, per zoning regulations the existing 25,700 SF lot is allowed a maximum of 50% (12,850 SF) of built upon/paved areas. Currently, almost the entire site is paved/built upon which translates to the existing site not meeting the current zoning requirements. Some form of relief, if not already given, will need to be applied for in respect to any new projects.

Considering the configuration and height of the Apparatus room (overhead doors on the front and rear of the space, pre-engineered metal building and 30 ft tall structure), an addition across the entire front or rear of the Apparatus Room would not be the most ideal solution due to the ramifications to access and the inability of the existing structure to support any additional loads (see magenta and red shaded areas in the image to the left). However, a two story addition (see the outlined rectangular enclosed red and green shaded area in the image to the left) could be constructed at the rear of the Apparatus Room by infilling a single overhead door and building across the rear of the Administrative Wing. This location would eliminate one of the overhead doors however it would allow for a true living quarters area on
